MISCELLANEOUS PAPER SL-86-7

FACILITIES TECHNOLOGY APPLICATION TESTS; CONCRETE REPAIR

Tony B. Husbands

Final Report

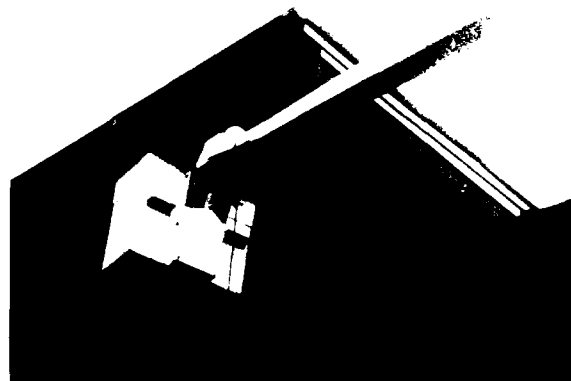
on the balconies and columns had previously been repaired by in-house personnel using a cementitious repair material, and a large number of these repairs had started to fail due to loss of bond and cracking. Spalling of the concrete columns is shown in Figure 4.

Figure 4. Spalling of concrete columns, Fort Bragg

49. All vertical spalls on the columns were repaired with an LMM. The spalled areas were prepared using the same method described in paragraphs 46 and 47. It was less difficult to remove the concrete around the reinforcing steel, and the reinforcing steel was completely exposed for most vertical spall repairs. A few of the columns had been repaired using a fast-setting cementitious patching material. Some of these repairs had started to fail because of excessive cracking and loss of bond. Four of these areas were repaired by removing the previous repair material and repairing again using the LMC. Preparation of these areas and the finished repairs are shown in Figures 16 and 17, respectively. Some of the vertical repairs were exposed to direct

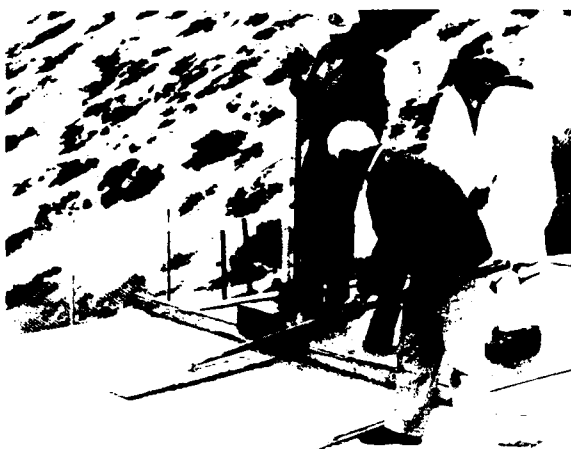
Figure 26. Application of polymer-concrete coating

59. An 8-ft vibrating screed was used to consolidate and spread the coating. A magnesium float was used to finish the surface of the coating (Figure 26). Every other circular area formed inside the screed rails was coated, and the following day the remaining areas were coated. This alternating procedure was used to provide a hard surface to support men and equipment while placing the freshly mixed polyester-resin concrete. New air ventilators were installed. The air ventilator base was placed over the air ducts and the coating was placed approximately 2 in. over the flange of the air ventilator base to hold the air ventilator in place (Figure 27).

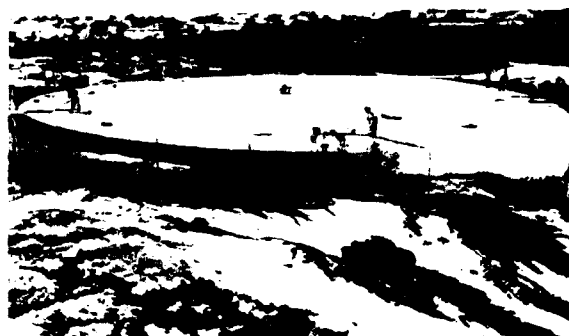
Figure 28. Finished coating on sand trap water storage tank

The finished coating of the sand trap water storage tank is shown in Figure 28. The light-colored areas are areas coated that day. The coating was trowelled on the top side of the wall section.
